Bulletin No.: PIT5853
Published date: 09/20/2021

PIT5853 Rattle Noise from Driver's Side Dash Area

Models

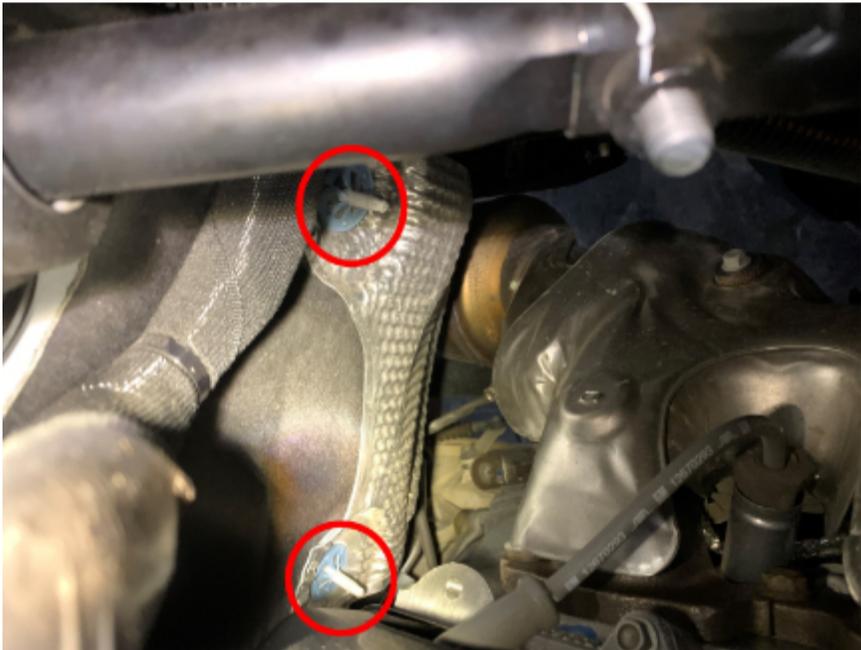
Involved Region or Country	North America
Condition	Some customers may comment on a rattle noise from the driver side dash area in park at idle or while driving.
Cause	The retainer clips that hold the Exhaust Front Underbody Heat Shield may have become loose, shown below.

Remove existing retainer clips and replace with updated retainer clip P/N 13232779 and tighten by hand until heat shield is secured into position.
